Noble Presence Services

July 30, 2004

Re: The "Tennent House"

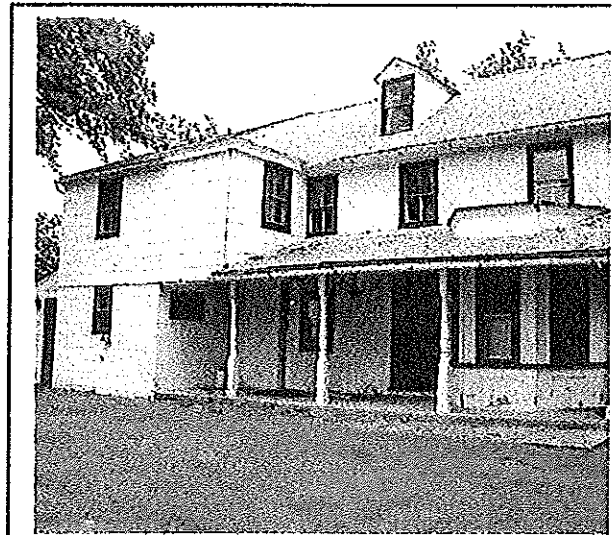
Figure 1. Looking northwest at the primary

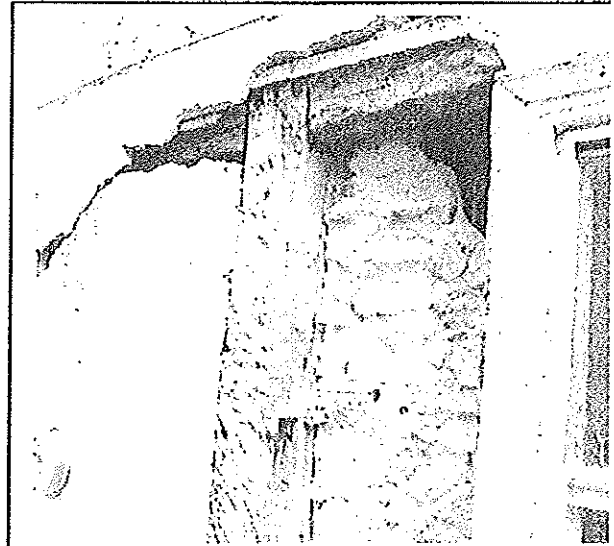
The timber framing of the portion of the building that is visible on the rear façade is, in my experience, a very rare and possibly unique, method of construction in Pennsylvania and the surrounding region. While only a small portion of the frame is exposed, it appears that the upright posts are mortised and pegged into the sill plate and are spaced approximately 2' plus on center. Each of the visible posts extends above the level of the window head and appears to extend above the level of the first floor ceiling. Because the stucco conceals the upper wall, the upper wall plate was not observed. Without removal of additional stucco (or possibly infrared photography) to expose more of the frame, it is impossible to determine if the building was originally two stories in height or if the posts terminate in an attic space where they may have framed a knee wall.

Additional mortises with double peg holes are located along each side of the posts documenting that the frame was joined with intermediate horizontal rails to form framed panels. The panels were infilled with stone and mortar, and considering the rough hewing of the framing, the walls were likely covered with some sort of cladding material.

Figure 3. View of exposed frame at the rear building. Note mortise in left post.

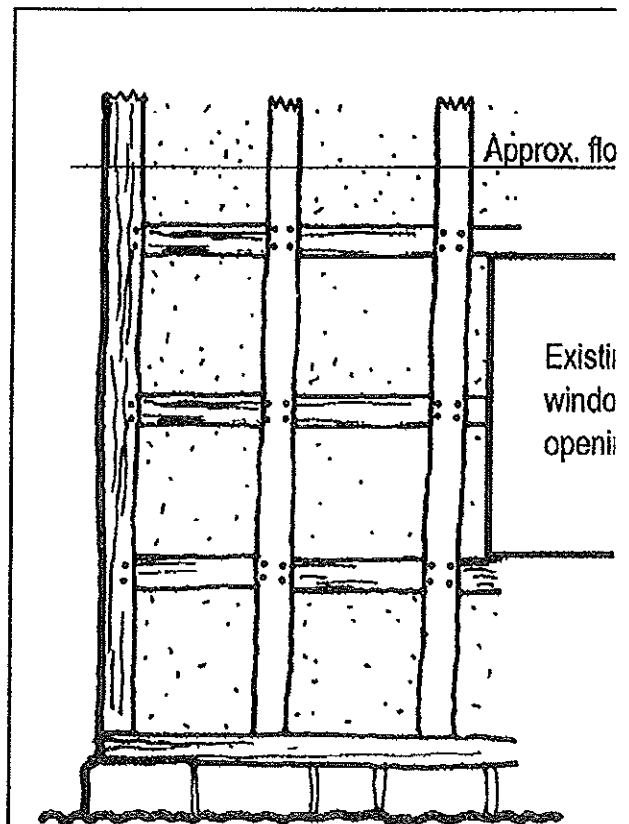
Figure 4. Hypothetical drawing of visible timber frame.
